State of Utah  
DEPARTMENT OF NATURAL RESOURCES  
DIVISION OF OIL, GAS AND MINING

RE: Site Inspection, S F Phosphate, Vernal Phosphate Operation, M/047/007 and E/047/048, Uintah County, Utah

**ATTACHMENT**  
**November 19, 2002**  
**Photographs**  
**S/047/007, SF Phosphate, Vernal Phosphate Operation**

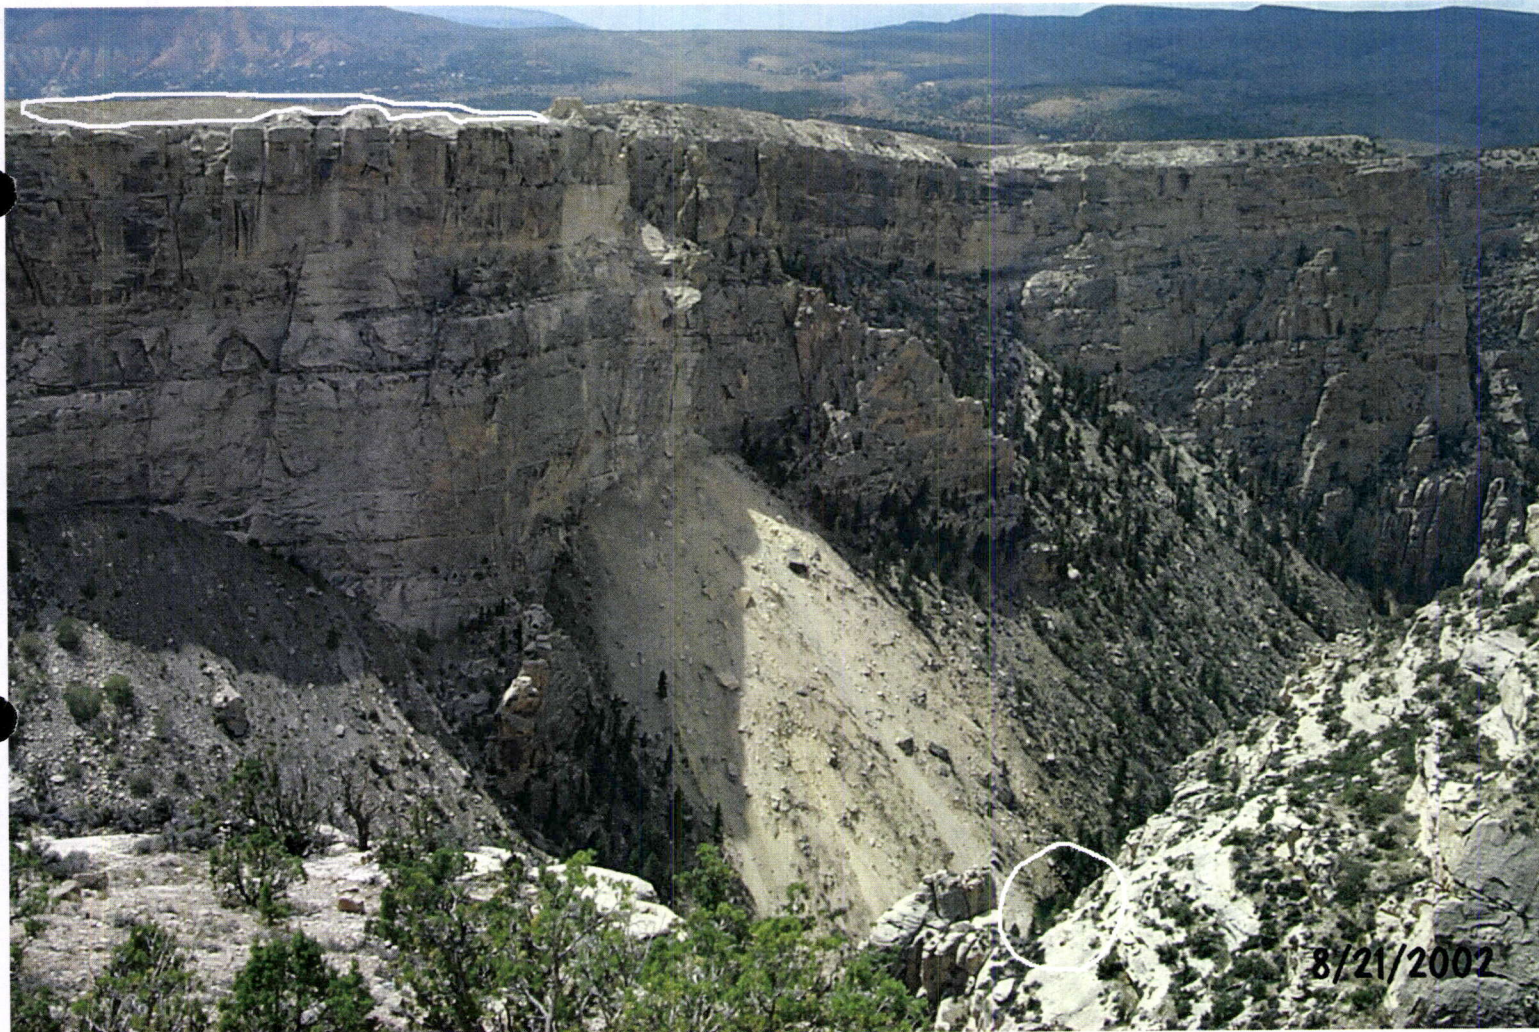
Mr. McCourt had reported a cliff spall into Big Brushy Creek, and we were able to look at it from a distance (see Photo 1). The spall originated from a point near some mined areas but not directly connected with them. Material from the spall has dammed the creek as can be seen in the lower circled portion of Photo 1.

**Photo 1. Cliff spall into Big Brushy Creek. The lower circled area shows a small pool of water created by the spall. The upper marked area is an area that was mined.**

Mining near the spall occurred several years ago, so although there is a chance that blasting loosened some of the rock and induced the spall, it could also have been completely natural. In either case, I do not believe there is any danger to the public, and the pond created by the spall may enhance wildlife habitat.
